Materials Testing on the DC-X and DC-XA

Dane Smith, Carol Carroll, Jochen Marschall, and
Joan Pallix

January 1997

Ames Research Center

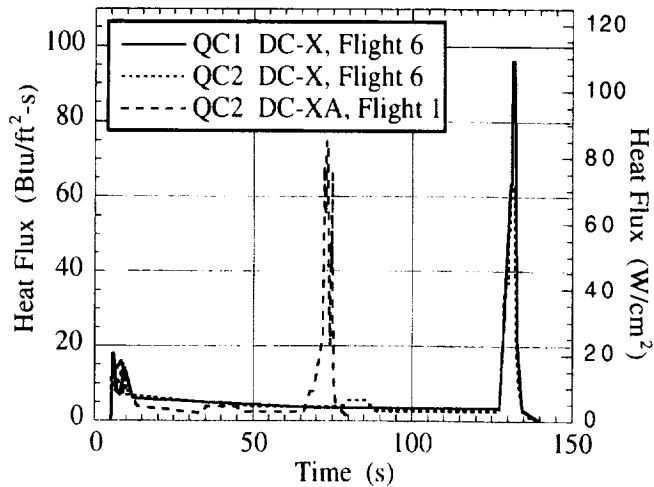
Figure 1(a). The approximations to the measured heat fluxes

TPS testing was carried out on DC-X flights 6, 7, and 8 (May 16, June 12, and July 7) in 1995. The most severe thermal environment occurred during vehicle landing. During landing the test panels were exposed to a short duration high temperature heat pulse (peak fluxes up to $\sim 100 \text{ W/cm}^2$) and in most cases were simultaneously impacted by debris from the concrete landing pad. Representative heat flux measurements from calorimeters located in the DC-X and DC-XA base heatshields are shown in figure 1(a). This data was transmitted by Mike Johnson of MDA (Huntington Beach). The heat fluxes measured by calorimeter QC2 are considered the best representation of the heating environment seen by the test panel; see figure 1(b). The initial rise in heat flux corresponds to vehicle lift-off (at about 5 seconds) and the large spikes to vehicle landing. The DC-X flight 6 heating conditions are typical for landings on concrete, which were the case for most of the Delta Clipper flights. The heating conditions for DC-XA flight 1 are for a vehicle landing on a metal grate.

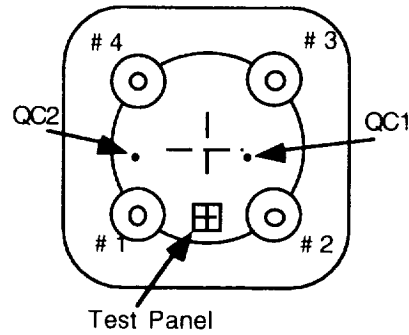
Figure 1(b). The locations of the two calorimeters relative to the test panel on the base of the DC-X and DC-XA.

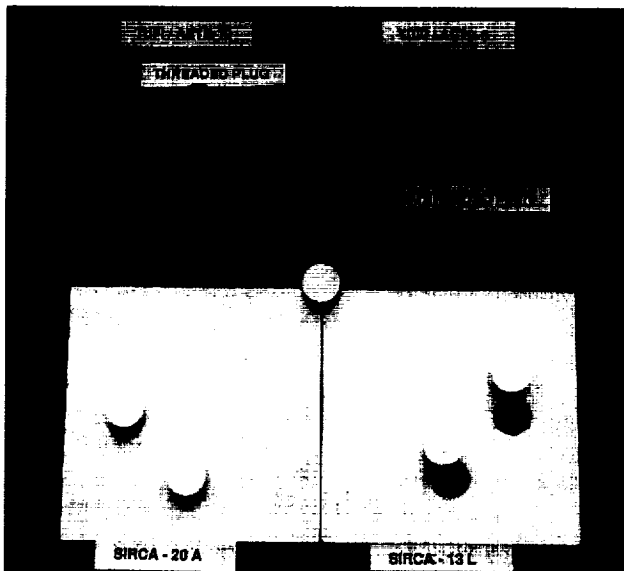
Figure 2(a). Pretest panel for DC-X flight 6. Contains different density TUF/AETB tiles (black) and SIRCA tiles (white). Note the nine plugs prepared to cover the attachment screws. Two of the plugs were machined out of TUF so that they could be screwed into place.

The TPS panel tested on flight 6 consisted of four 6 inch \times 6 inch \times 1 inch tiles of different densities. Two Toughened Unipiece Fibrous Insulation (TUF) tiles were prepared from 8 lb/ft³ and 12 lb/ft³ Alumina Enhanced Thermal Barrier (AETB) ceramic substrates, and are shown in figure 2. TUF tiles were developed specifically to be resistant to impacts. The white Silicone Impregnated Reusable Ceramic Ablator (SIRCA) tiles in the photo were prepared by silicone impregnation of 9 lb/ft³ and 18 lb/ft³ silica tile substrates.

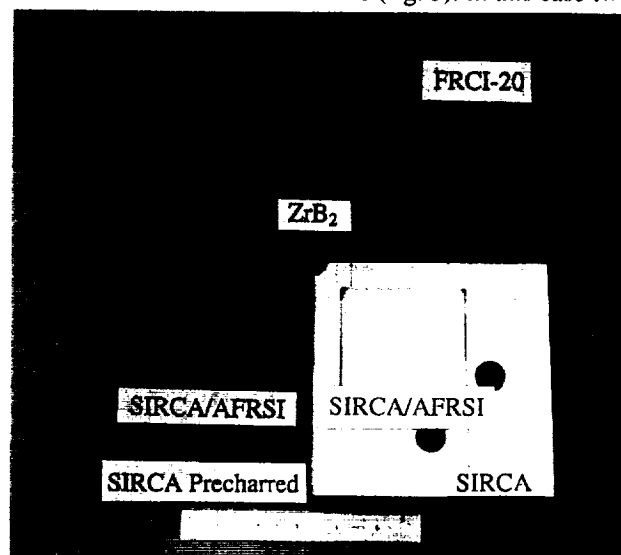
Figure 5(a). DC-XA flight 1 pretest panel. Contains TUF1/FRCI-20, a ZrB_2 composite, SIRCA tile and silicone impregnated AFRSI blankets with and without precharring.

As mentioned previously, a similar blanket did not survive the more extreme conditions of the base heatshield on flight 7 of the DC-X. On the first flight of the DC-XA a more durable blanket was tested on the base heatshield but still did not survive (fig. 5). In this case two

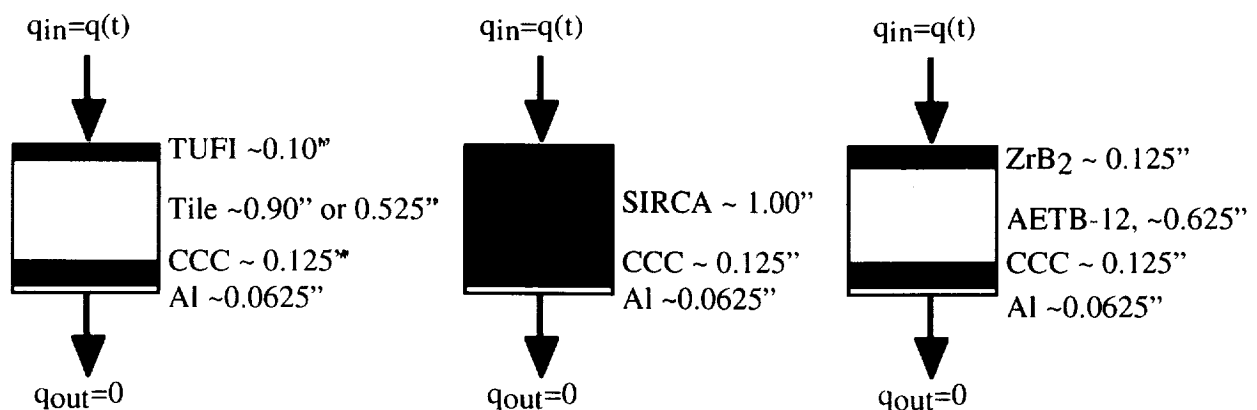
Figure 7. Schematics of the tile, SIRCA, and ZrB₂ panels analyzed.

Schematics of the material geometries analyzed are shown in figure 7. The materials involved are the reusable surface insulation (RSI) materials AETB-8, AETB-12,

and FRCI-20, the light weight ceramic ablaters SIRCA-14 and SIRCA-18, and a diboride ceramic matrix composite. The tile panels consisted of 1 inch or 5/8 inch thick tiles bonded to a 1/8 inch thick carbon-carbon composite (CCC), which was mechanically attached to a 1/16 inch thick aluminum sheet. The AETB and FRCI tiles had a TUF1 coating with a thickness was about 0.1 inch (out of the total tile thickness). In practice, an effective thickness was calculated from tile and TUF1 densities such that the total added mass per unit area was equal to the manufacturing goal of 0.17 g/cm^2 ; i.e.,

The SIRCA panels all consisted of 1 inch thick SIRCA bonded to CCC and attached to an aluminum sheet. The ZrB_2 sample was 1/8 inch thick and was held on top of a 5/8 inch thick AETB-12 tile by a TUF1/FRCI-20 frame. This tile was bonded to CCC and attached to an aluminum sheet. The thermophysical properties of AETB-8, AETB-12, FRCI-20 and ZrB_2 were obtained from the TPSX data base (ref. 10). The properties of the TUF1 coating on the different tiles were communicated by Dave Stewart (Ames). Those for SIRCA-14 and SIRCA-18 were estimated from data obtained by Energy Materials Testing Laboratory for a SIRCA-14 material under reduced pressures (0.05, 0.01, and 0.001 atm). Extrapolation of thermal conductivity data to atmospheric pressures was done using a logarithmic fit to the measured data. Values for SIRCA-18 were further

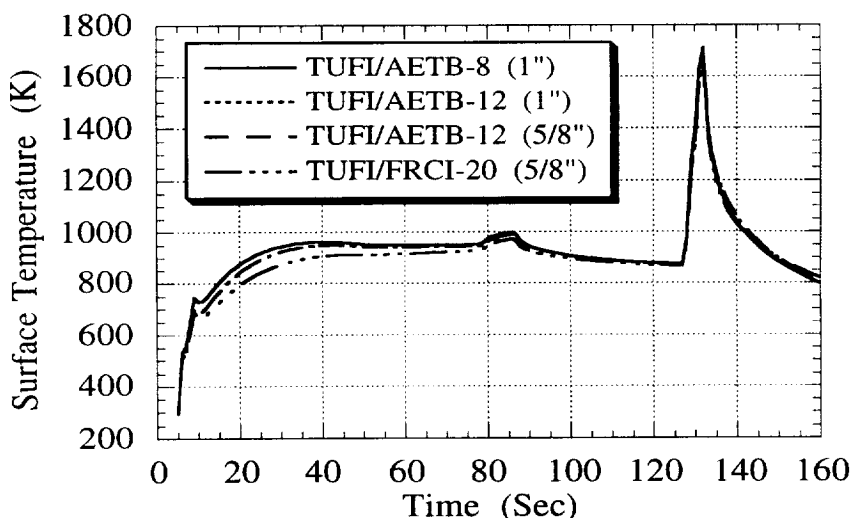
Figure 8. The temporal variation of the surface temperature for four RSI test panels exposed to the heat flux measured by calorimeter QC2 on DC-X flight 6.

The computed surface temperatures for the RSI tile test panels on flight 6 of the DC-X are shown in figure 8. The 1 inch and 5/8 inch thick tile specimens show the same surface temperature transients because both are sufficiently thick for very little heat to be drawn from the surface into the CCC and aluminum (over the time scale plotted). The maximum surface temperatures are reached during vehicle touchdown; about 1710 K for AETB-8 at 132 seconds. RSI materials are poor conductors of heat and their surface temperature response is driven by the need to reradiate most of the incoming heat flux. This response is modified in the present case by the thermal mass of the TUF1 layer, which damps the rise in surface temperature somewhat. Generally, lower density tile

materials also have TUF1 coatings which are of lower density and which extend further into the material. As a consequence the surface temperature response is fastest on the AETB-8 tile and slowest on the FRCI-20 tile.

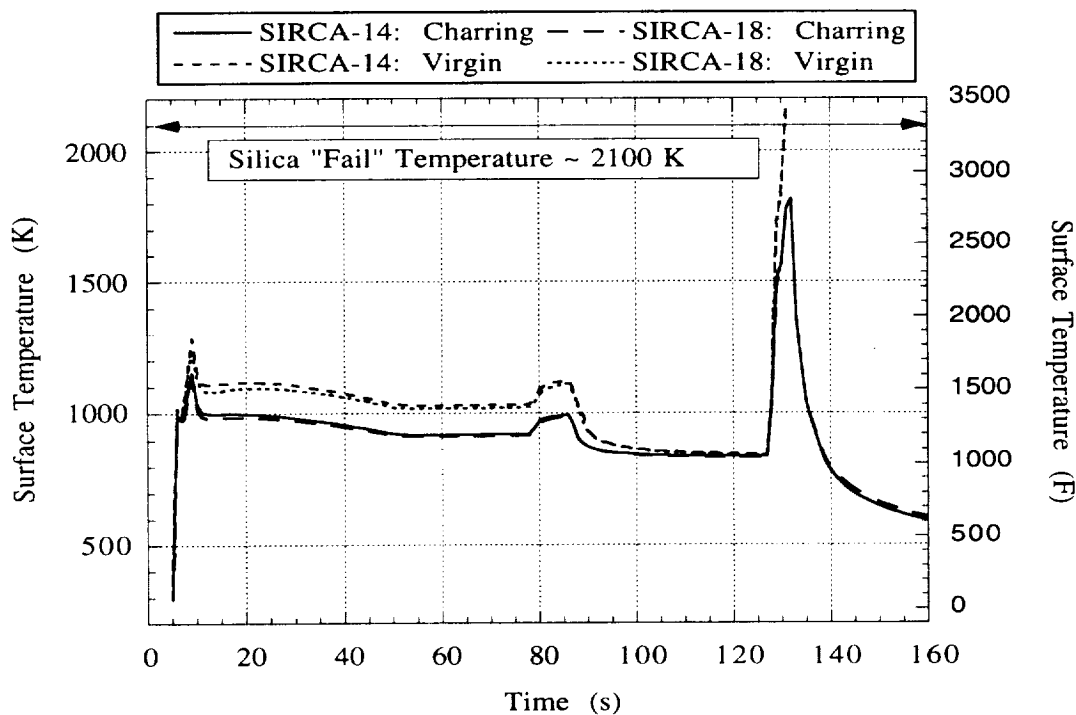
Figure 9. The temporal variation of the surface temperature for SIRCA-14 and SIRCA-18 test panels exposed to the heat flux measured by calorimeter QC2 on DC-X flight 6.

The calculated variation of surface temperature on the SIRCA test panels is plotted in figure 9. Again, because heat conduction away from the surface is minimal and surface temperatures are largely controlled by the reradiation of energy which depends on the surface emittance, the temperature variations for SIRCA-14 and SIRCA-18 are almost identical. The surface temperature response to changes in input heat flux is much quicker for SIRCA than for the RSI tile materials because the damping provided by the TUF1 layer is not present. The temperature dependent emittance of virgin and fully charred SIRCA has been estimated in reference 5 from room temperature reflectance measurements. The emissivity of the charred material is relatively insensitive to temperature, with values of about 0.95. The emissivity of the virgin material varies greatly, dropping from a room temperature value of about 0.92 to about 0.58 at 1000 K and 0.33 at 2000 K. (These high temperature values for virgin SIRCA assume no char formation at elevated temperatures.) The silicone resin which impregnates SIRCA's silica tile substrate pyrolyzes over a

temperature range of about 500 K to 1000 K. In the present computations the virgin emissivity values were used up to 500 K and the char values were used once the surface temperature had exceeded 1000 K. As the surface temperature increased from 500 K to 1000 K, a linear combination of virgin and charred values was used. Because the surface composition of SIRCA depends upon the particular thermochemical reactions which take place upon heating, it is possible that the emissivity may be lower in some heating environments than in others. The limiting case would be that of negligible char formation, corresponding to the emissivity of a virgin surface. This case is also illustrated in figure 9. The approximate "fail" temperature of silica is 2100 K—around this temperature the material is sufficiently soft that it will flow under aerodynamic forces. The present computations suggest that a charring SIRCA material should survive the DC-X landing environment, reaching a maximum surface temperature of about 1820 K. A virgin surface, however, would not survive, as surface temperatures significantly exceed 2100 K during landing (computations were terminated at 2100 K). The SIRCA-14 and SIRCA-18 test panels which were flown on flight 6 of the DC-X had a charred appearance, yet also showed significant melting, while the neighboring TUF1/AETB-8 and TUF1/AETB-12 panels showed no evidence of melting. This may indicate

that the emissivity of the SIRCA samples pyrolyzing in the DC-X heating environment was lower than the ideal char values. Various possible scenarios can be constructed to support this possibility (e.g., the mechanical damage from debris during landing could have exposed virgin material during landing or perhaps the size of the heat pulse during landing was too large and sudden to allow time for char formation before the surface temperature increased past the silica fail temperature), however these are only speculative.

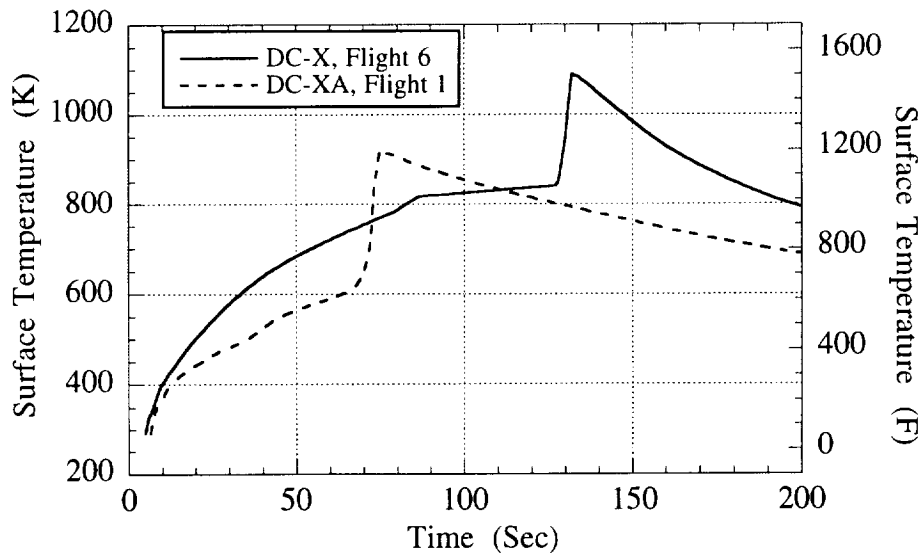
Figure 10. The computed surface temperature of the ZrB_2 specimen for the QC2 calorimeter heat fluxes measured on DC-X flight 6 and DC-XA flight 1.

Figure 10 shows surface temperature profiles computed for the ZrB_2 specimen using the heat fluxes measured by calorimeter QC2 on DC-XA flight 1 and DC-X flight 6. (This specimen was only flown on DC-XA flights 1 and 3, however DC-X flight 6 heat fluxes are typical of all landings on concrete and should be representative of conditions experienced on DC-XA flight 3.) The maximum surface temperature reached on the ZrB_2 specimen for the DC-X flight 6 heat flux is about 1100 K. This is hundreds of degrees lower than the temperatures reached by the tile and SIRCA specimens for the same conditions. It is also clear from figure 10 that the temperature response to heat flux variations is much slower than for the tile and the SIRCA samples. Both of

these effects are a direct result of the large thermal mass and relatively high conductivity of the ZrB_2 test specimen. This combination allows the specimen to absorb a large quantity of energy and heat up almost uniformly, with a resulting damped rise in surface temperature.

Flight 1 of the DC-XA was shorter than usual and ended with the vehicle landing on a metal grate to reduce impact damage from spalled concrete. The surface temperature still rises substantially upon landing but the maximum surface temperature reached by the ZrB_2 specimen is lower by almost 200 K. Similar computations for a 5/8 inch thick TUF1/FRCI-20 tile (not shown in fig. 10) also gave lower surface temperatures for DC-XA flight 1 than for DC-X flight 6, though in this case only by about 100 K. This lower surface temperature is due to the lower total heat load because of the shorter flight time and can not be attributed to landing on the grate. However, during flight 1 the engines apparently failed to shut down properly after landing and ran for an additional 2.5 seconds. Thus it is still likely that for identical engine performance and flight times, landing on the grate would contribute to reduced peak surface temperatures when compared to landing on the concrete pad.

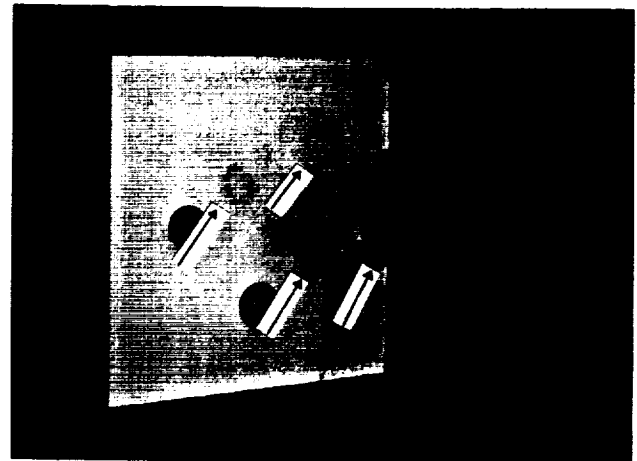
Figure 13(b). MDTI-AETB-16 showing preflight repair using quickfix with and without high emissivity agents.

The AETB-16 tile was supplied with a high density coating which raised the density to 38 lb/ft³. The damage areas shown in figure 13(a) were made with a screwdriver just to demonstrate the repair process. There are four damaged areas including two on the surface that are approximately 0.75 inches long and 0.5 inches across and 0.25 inches deep. Another larger area on the surface is about 1 inch in diameter and 0.5 inches deep. The fourth damaged area is along the edge of the tile and is the largest at about 2 inches long and 0.5 inches deep. Figure 13(b) shows that the damaged edge and the large hole were repaired using black quickfix and the two smaller holes were repaired using a white quickfix.
